Site Visit Report

Project: Gristmill Village

February 3, 2017

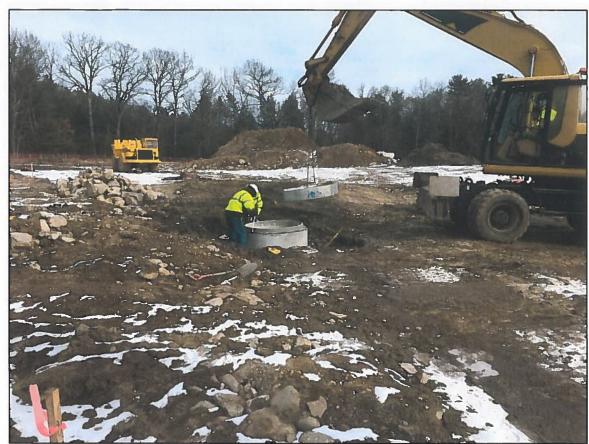
Structures were installed on a bedding of crushed stone and kent seal was installed between sections. The structures were being backfilled with sorted trench spoil as there were many large rocks and boulders within the soil. The backfilled material was compacted around the structure using a vibratory plate compactor.

Photo 1: Installation of CB-5 with Kent seal between sections.

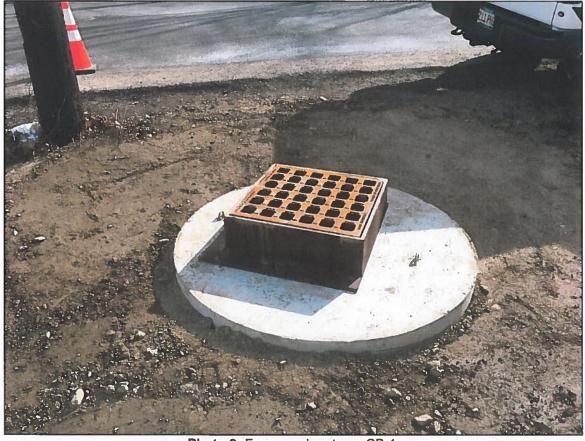
During my visit, DiPilato was backfilling CB-5. Upon completion, they began excavating for CB-7 (5-foot diameter, double-grate catch basin) located at the end of the southwestern cul-de-sac. Additionally, frames and grates were being set upon the tops of the previously-installed catch basins.

Photo 2: Frame and grate on CB-1.
